# WEST CASE PARK

Vision Plan Summary - June 2023

COLUMBUS RECREATION  
& PARKS DEPARTMENT

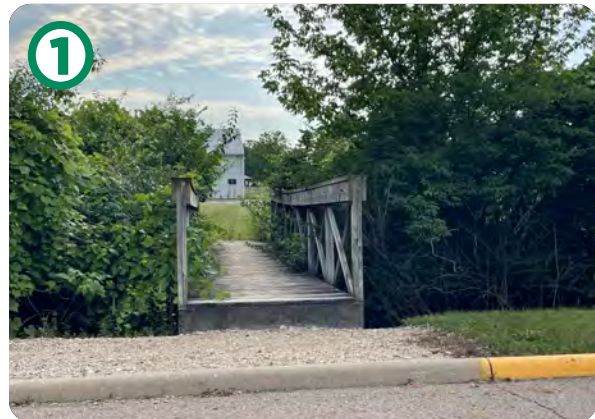
- Informal access paths encourage community engagement with site.
- Southwest corner missing critical connection to Carriage Place Community Center. Could be easily achieved with addition of +/- 120' pathway through easement.
- Missing opportunity for a more direct connection with Daniel Wright Elementary.

1 Bridge, Daniel Wright Elementary

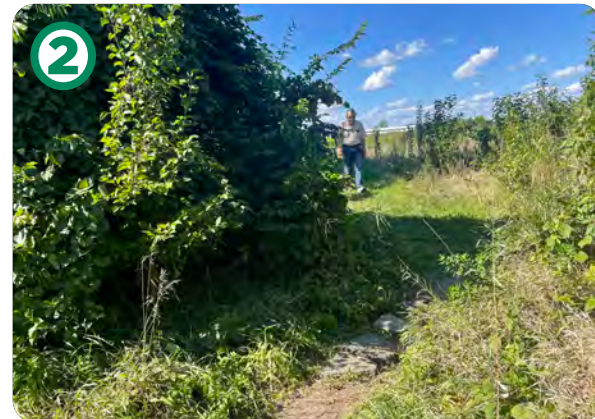
2 Connection, Sterling Place Apts.

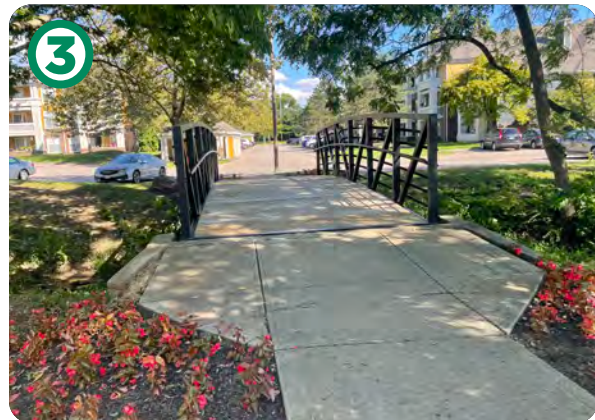
3 Bridge, Sterling Place Apts.

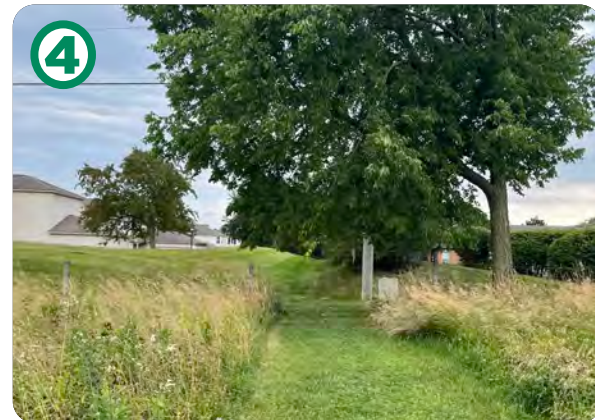
4 Connection, Bethel Village Condos

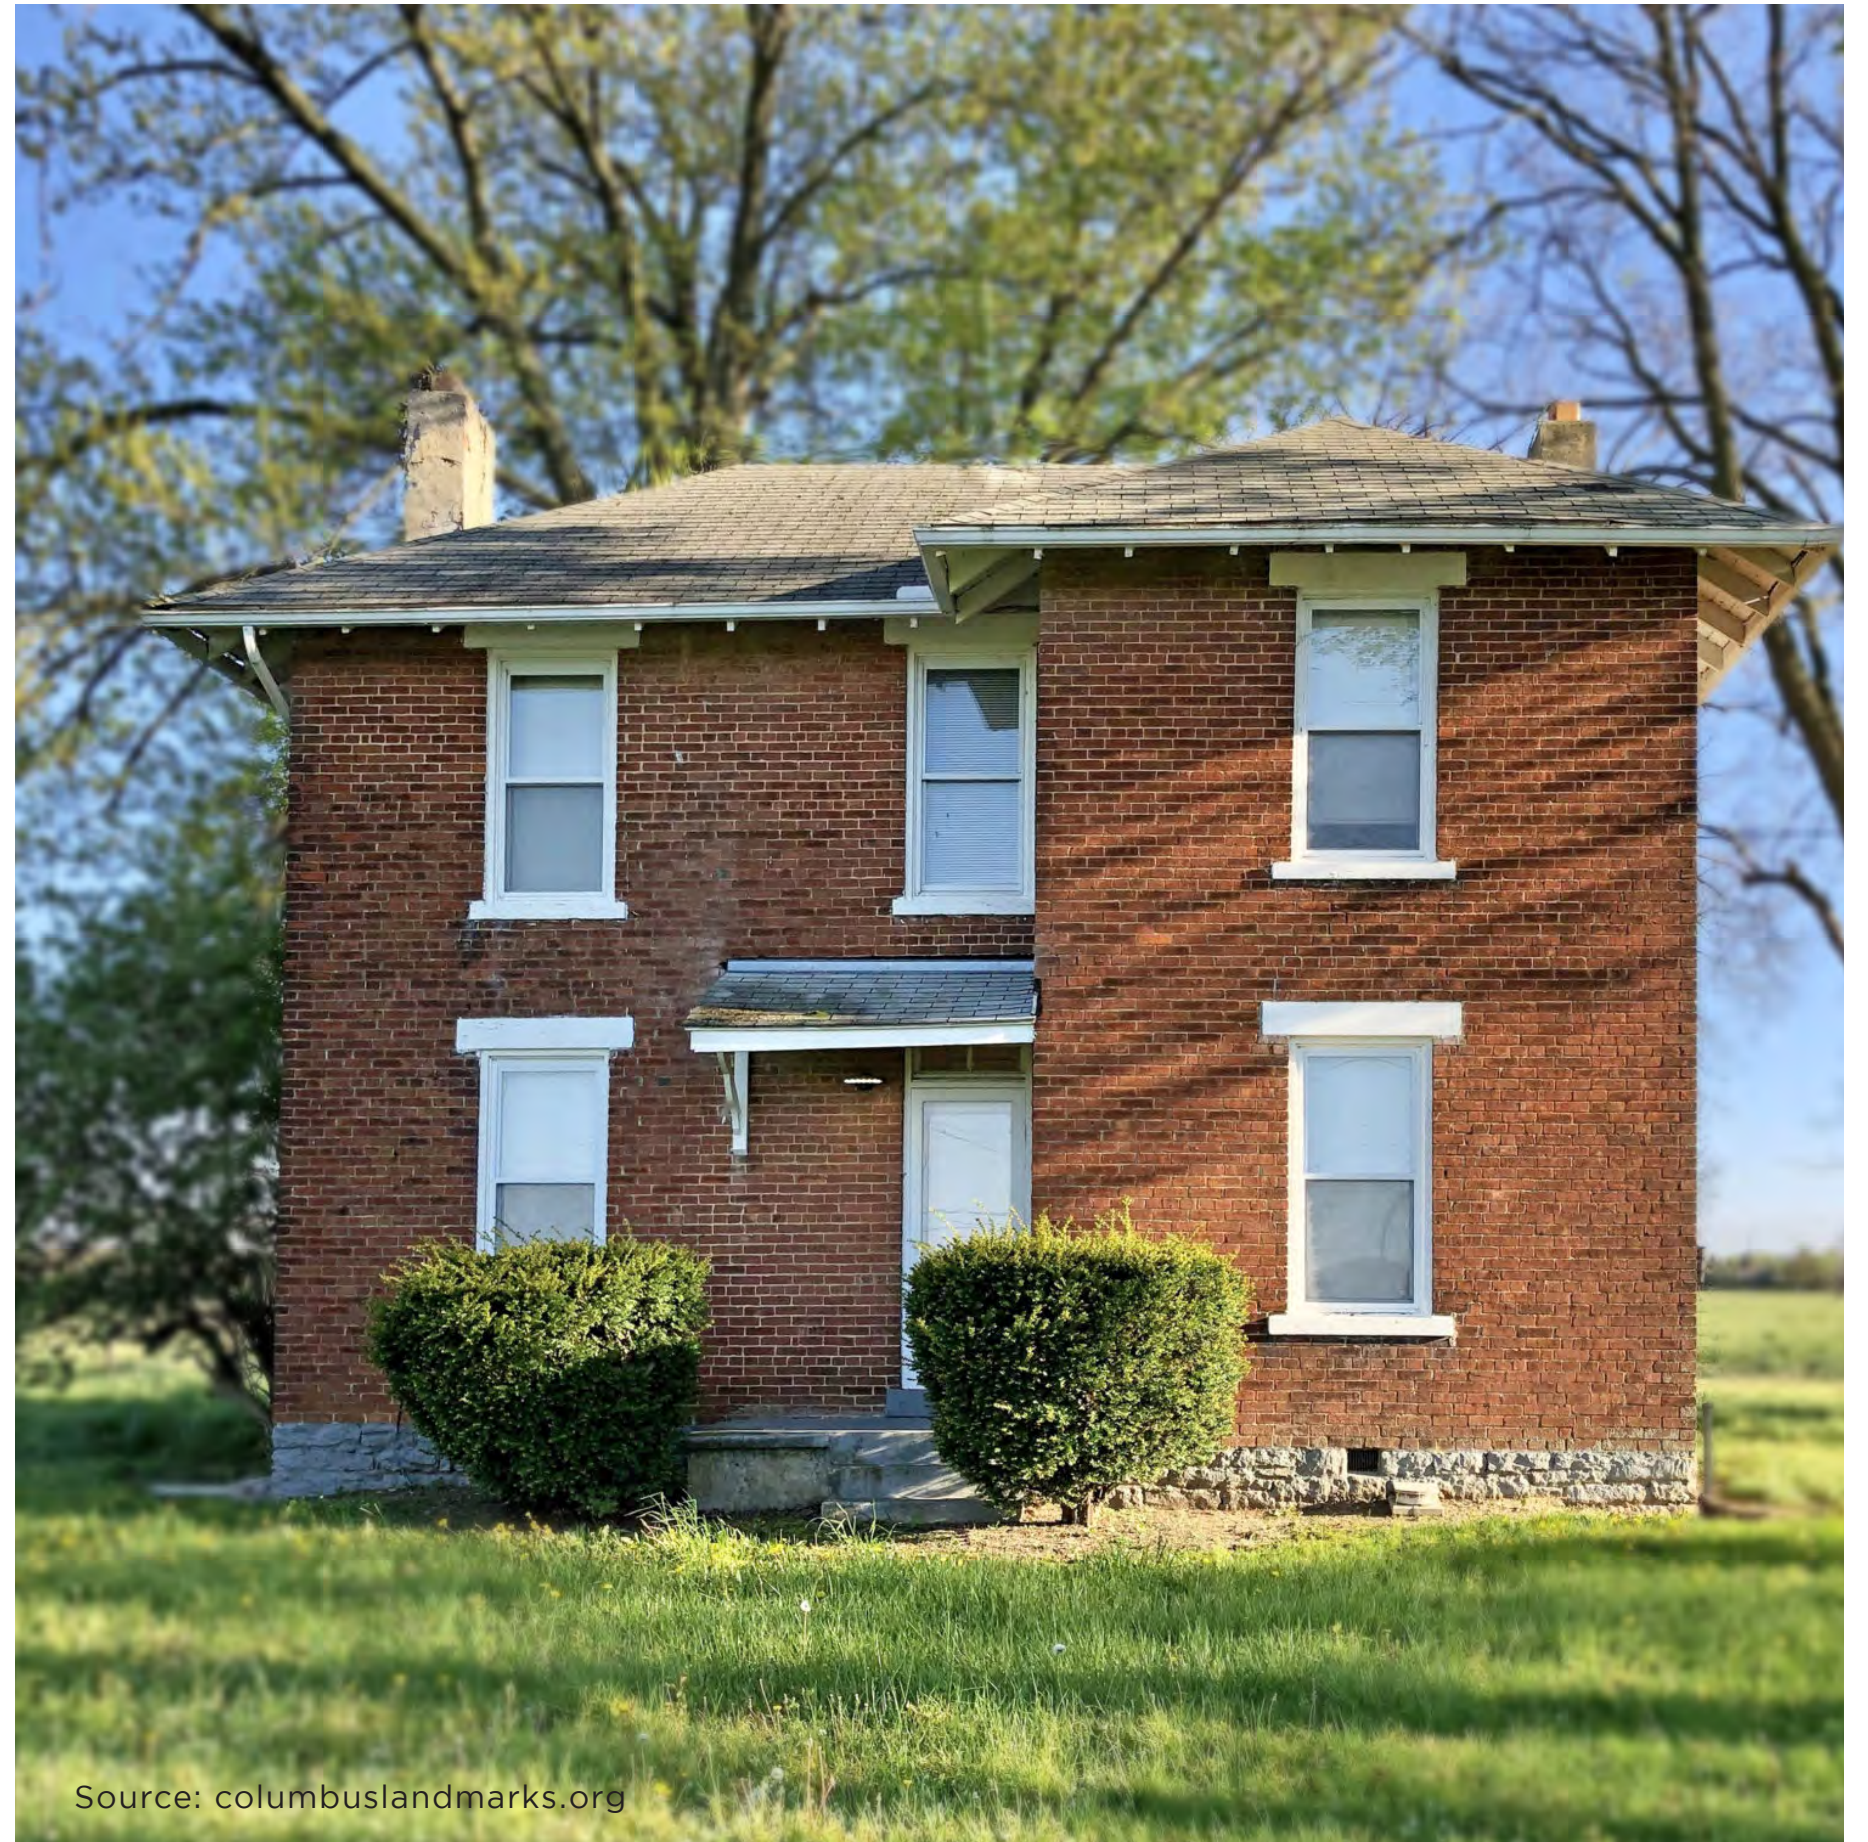
- The brick farmhouse has been estimated to be built during the 1880s as a residence at 2425 West Case Road, Columbus, Ohio 43235. At that time, Case Road was a residential dirt road leading to the 58-acre parcel. This home is one of the oldest remaining structures in northwest Columbus and is an important example of rural architecture for the community.

- The home was originally owned by William F. and Maude Lane as a residence. The brick house was built in the simple Federal Style, with windows that are three-ranked (three windows across on the second story with two windows and a door on the first story), stone lintels over door and window openings, limestone foundation (basement) walls and a hipped roof with exposed rafter ends. The front door overhang and rear extension were later additions.

- The farmhouse is in fair condition and was recently used as a meeting space when The Ohio State University owned the sheep farm property.

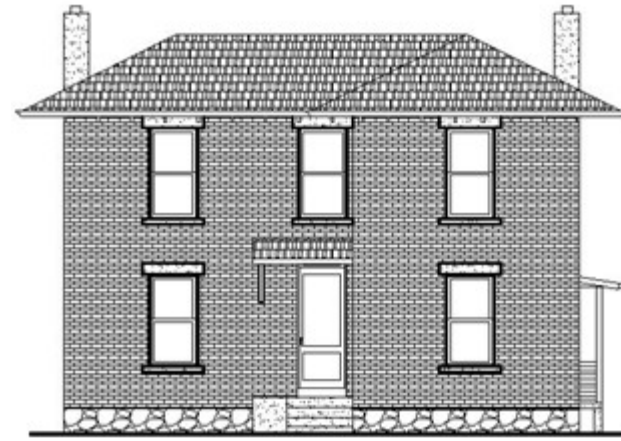
Building 1 - North Elevation

- Federal brick architecture with symmetrical 3-ranked front windows/door.
- There is an early wood porch and one-story brick addition.
- There is a later wood siding kitchen addition to the back (south-east).
- Non-compliant ADA entries (min. door width, steps only, no ramp).

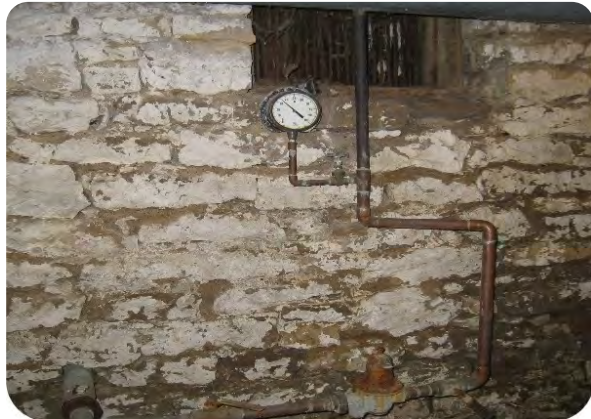
- 6'-0" Clear ceiling height is non-compliant, no occupancy allowed.
- Existing stair width and rise/run dimensions are non-compliant.
- Crawl space is non-accessible, shoring added for structural support.
- Water heater and furnace are dated, propane heat.

6'-0" Ceiling height - stone foundation walls

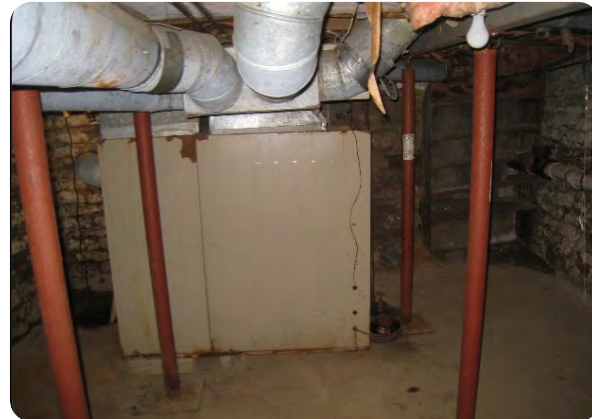
Older furnace

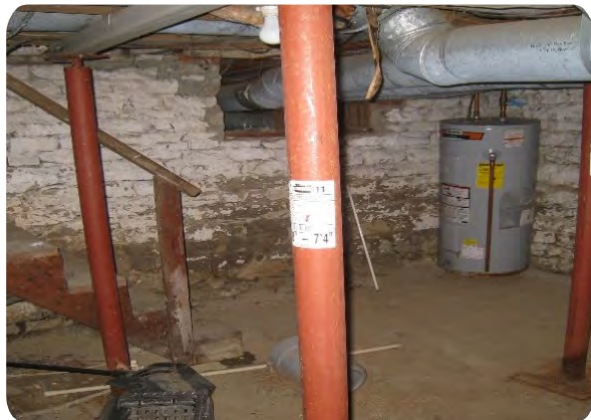
Shoring posts and older water heater

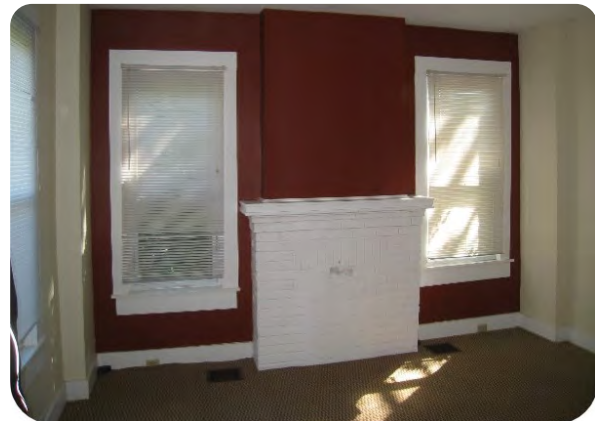
Painted brick fireplace used as a furnace vent

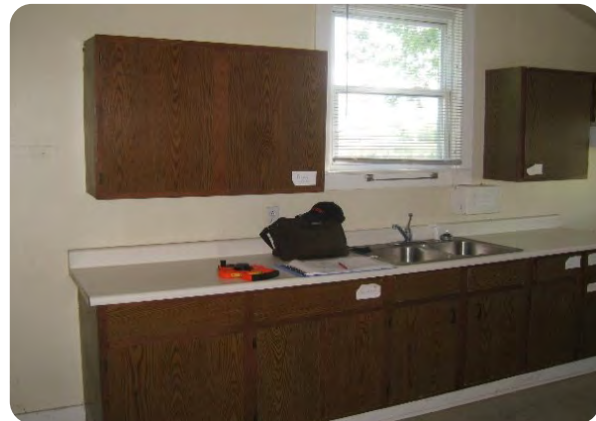
- Existing stair width, ceiling height, and rise/run dimensions are non-compliant.
- Existing front, rear, and side door widths are non-ADA compliant.
- Existing restroom fixtures are non-ADA compliant, no 5' turning radius.
- Existing kitchen counter height and sink configuration are non-ADA compliant.

Existing kitchen sink and counter

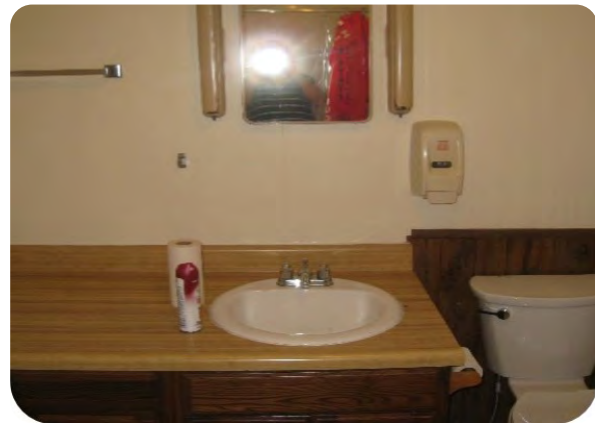
Existing restroom and toilet

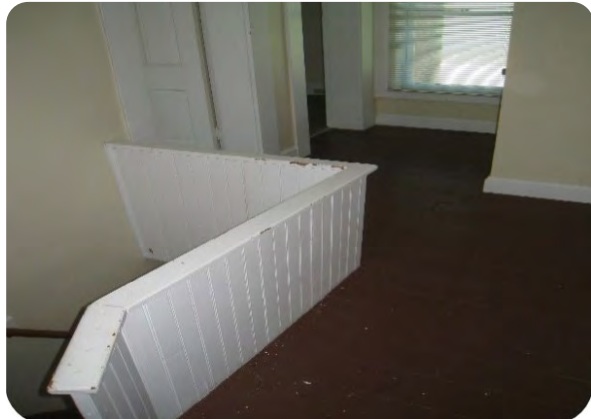
- Existing stair width, ceiling height, and rise/run dimensions are non-compliant.
- Existing stairway guard-wall assembly non-compliant (height).
- Low window heights will need to be protected if room is occupied.

Existing stairway guard-wall assembly

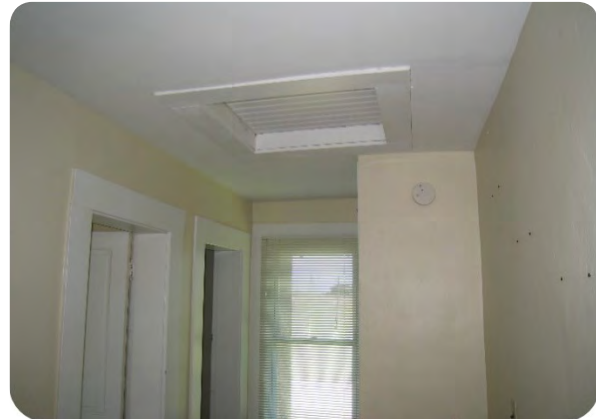
Existing attic access panel in hallway

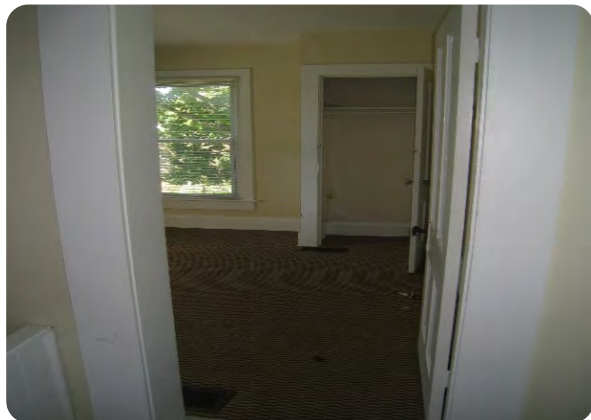
Existing bedroom with added closet

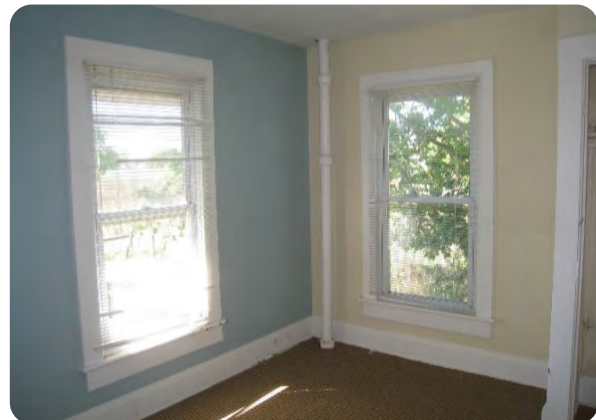
Existing bedroom (exposed vent pipe)

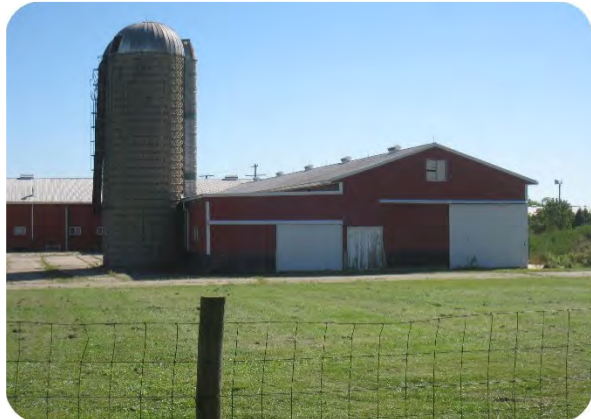
Building 2 - East Elevation

- Wood truss pole barn construction, metal roofing and siding, wood wainscot.
- Entries and interior door dimensions appear to be ADA compliant.
- Existing restroom fixtures are non-ADA compliant, no 5' turning radius.
- Existing kitchen counter height and sink configuration are non-ADA compliant.

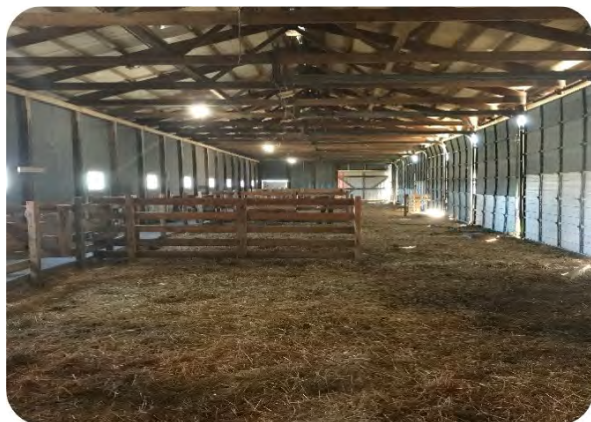
Existing barn interior

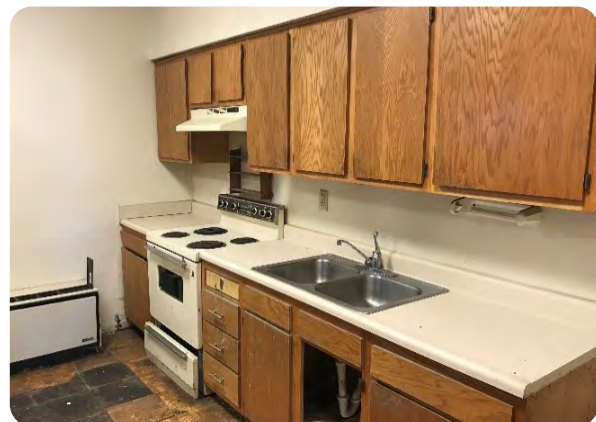
Existing kitchen

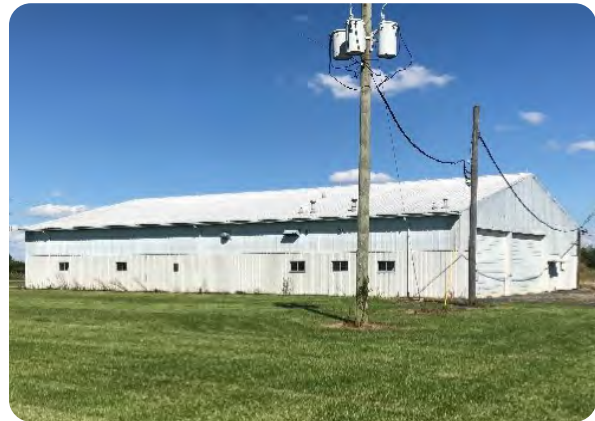
Building 3 - East Elevation

- Wood truss pole barn construction.
- Metal roofing and siding.
- Gravel or soil floor surfaces.

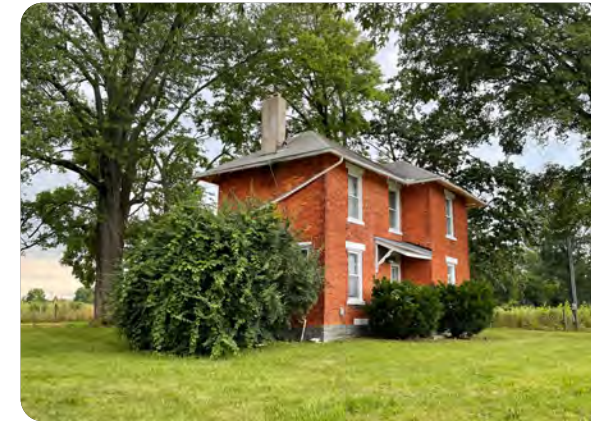
### ARCHITECTURE

#### FARMHOUSE

- In **good shape** for its age, simple to update from a code/cost standpoint.

#### RED BARN

- In **good shape, simple to update** from a code/cost standpoint.
- **Usable for a variety of functions** depending on final program.

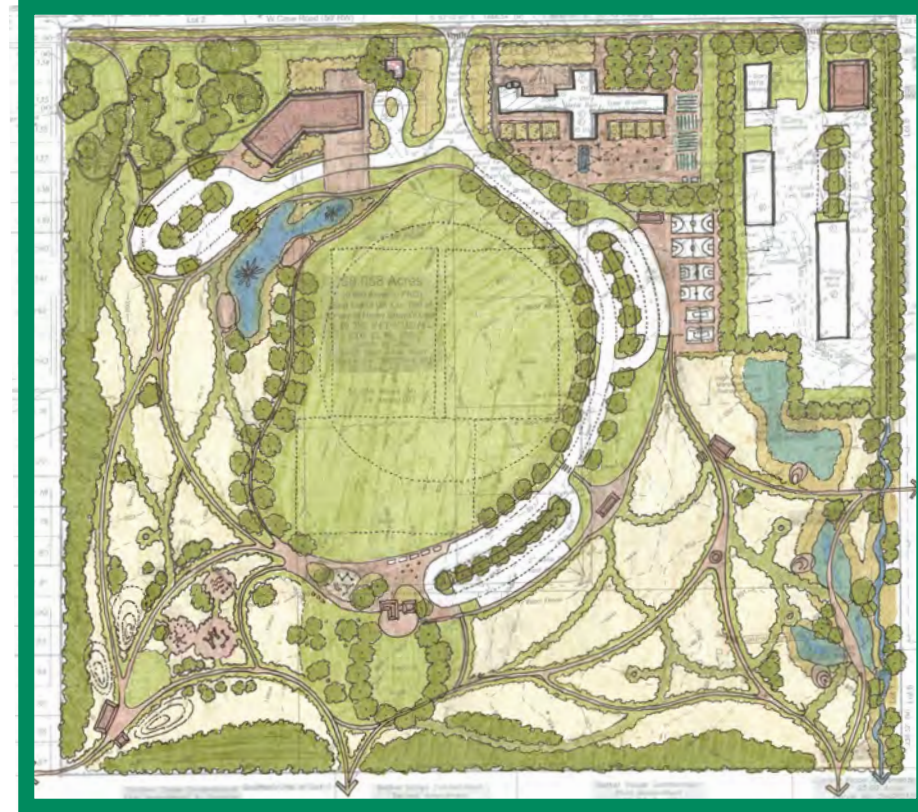
- 1) Provides single entry off West Case Road- shared access for park and future library branch, with separate Forestry complex entry.
- 2) Future development - high flexibility.
- 3) Retain historical influence - high.
- 4) Slate Run improvements - overwide stream channel and native plant restoration.
- 5) Site infrastructure - moderate/high impact on 3/4 of the site but provides direct vehicular and pedestrian access throughout the park.

- In Option B, there were many complaints about how intrusive the parking feels as it protrudes far into the heart of the park. However, this design makes more park amenities accessible to people of all ages and abilities.
